**ASBESTOS/LEAD
SURVEY**

5849 Schaefer Avenue
Chino, California

Ambient Environmental Inc. Project #20-1273
June 2020

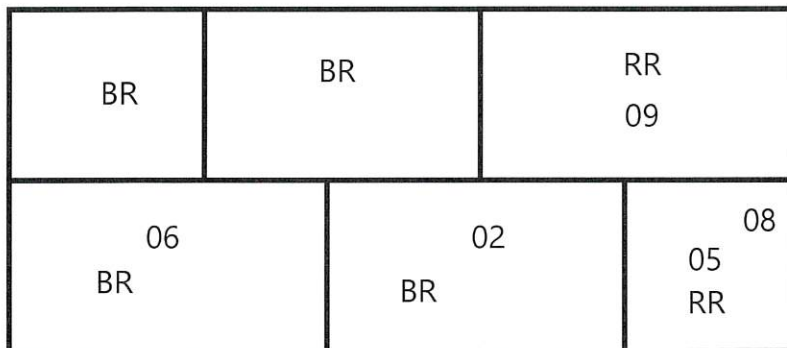
SITE DRAWING

ROOF 16, 17, 18, 19, 20, 21
