**ASBESTOS/LEAD
SURVEY**

13770 Oaks Avenue
Chino, California

Ambient Environmental Inc. Project #20-1273
June 2020

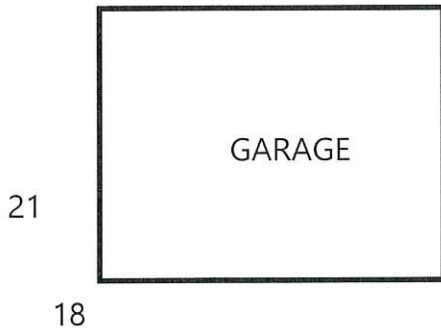
28 ROOF 22, 23, 24, 25, 26, 27 30

WOOD SHED

29 SITE LOCATION 13770 OAKS AVENUE
 CHINO, CA

DRAWING NOT TO SCALE

APPENDIX C SITE DRAWING WITH SAMPLE LOCATION
