RE: Archaeological Resources Records Search Results for the 13925 Benson Avenue Project,
San Bernardino County, California

Archaeological Records Search Results

CALIFORNIA HISTORICAL RESOURCES INFORMATION SYSTEMS RECORDS SEARCH

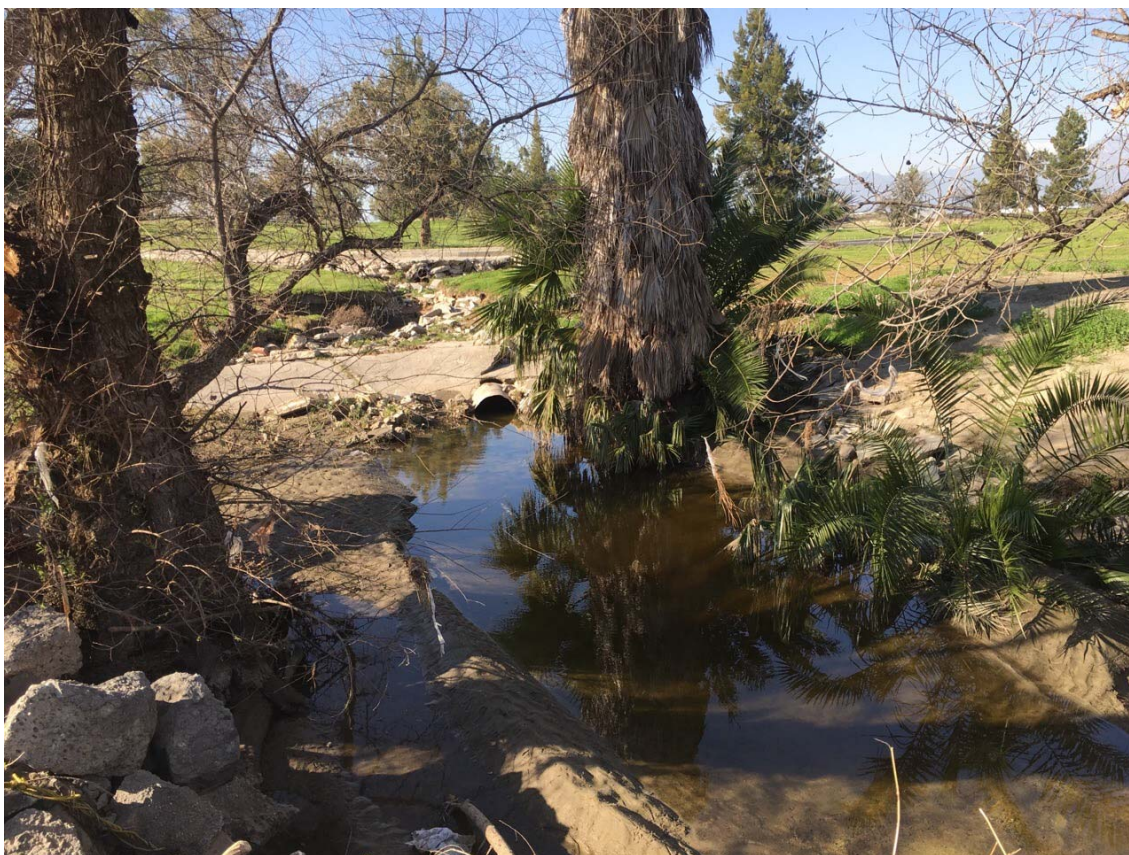
Overview of P-36-024903 including modern culverts, facing north.

This resource was recorded in 2012 by M. Dice as the open-air Cypress Channel, which was likely dug before 1938 to remove excess water out of orchards (Dice 2012). P-36-024903 was observed, as previously recorded during a survey by ICF archaeologists (2017) and appears to be currently used by the El Prado Golf Course for channeling runoff water. Only the portion running underneath and approximately 150 feet on either side of Pine Avenue was included in this 2017 survey. Modern culverts appear to have been added for sections of the channel undercutting portions of golf cart access roads for the El Prado Golf Course. Ornamental vegetation including palms were observed on either side of Pine Avenue along this earthen channel. This resource was previously found to be ineligible for inclusion in the NRHP and CRHR, which was supported by the most current survey.

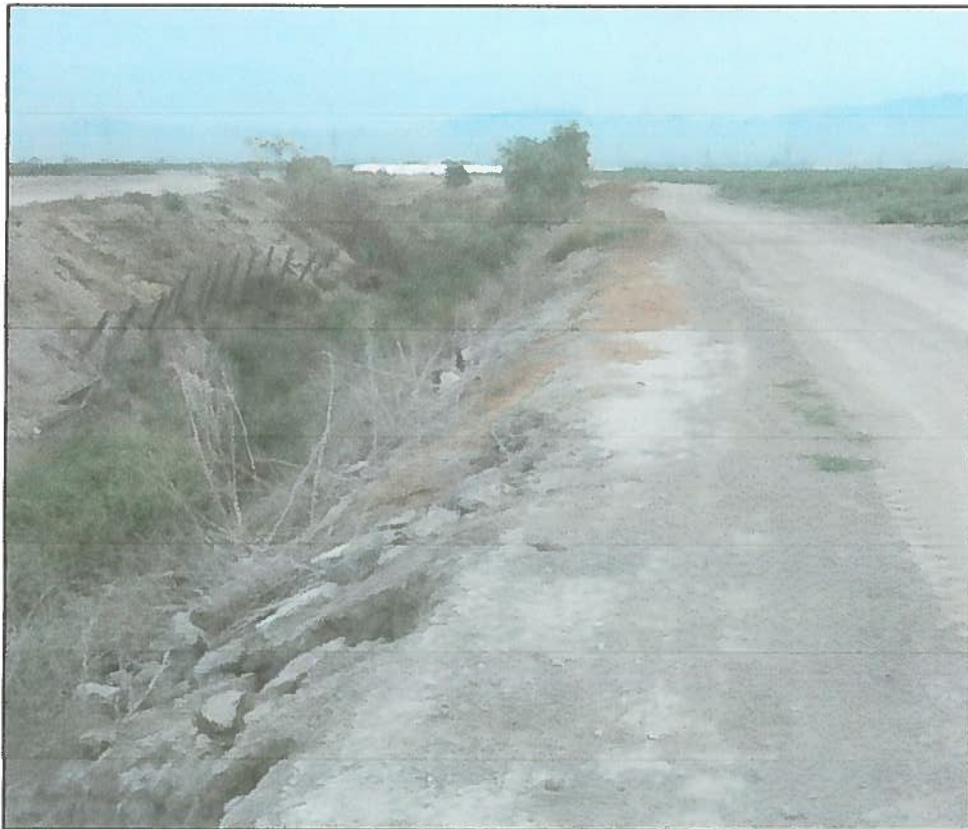
View north-northwest of the Cypress Channel showing the cut walls, railroad tie shoring and wire fence.

Near the Majestic project site, the channel consists of a trench cut to about 10 feet below existing grade using heavy equipment, then shoring in the form of cut railroad ties and wire netting had been placed along the edges of the cut channel so as to hold back erosional deterioration. Soils located below the plow zone of adjacent properties can be observed, but an extensive amount of dumping had occurred due to the open nature of the channel in this area. Piles of concrete, vegetation, wood and trash can be observed.

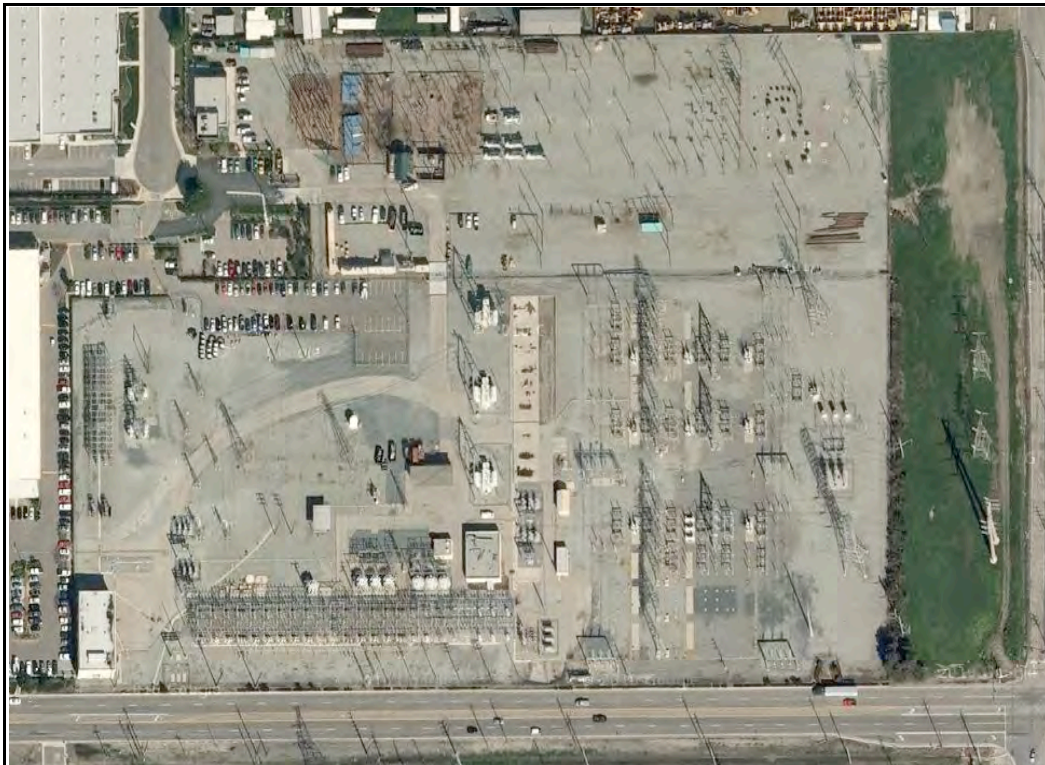
*P5b. Description of Photo:
Current aerial image showing the configuration of the Chino Substation.

The six buildings situated throughout the property include the Substation Building (circa 1912), Exciter House (circa 1938), Control House (1938, remodeled in 1950 and 1991), Garage (circa 1940s), Electrical Equipment House (circa 1991), and Oil House (circa 1940s). The property exhibits a range of architectural styles indicative of the programmatic use, the property owner, and the period of construction having been developed to include buildings in the Stripped Classical, Streamline Moderne, Neo-Moderne, and Utilitarian styles. Overall, the buildings and associated site features observed at the property appear to be in fair to good condition.

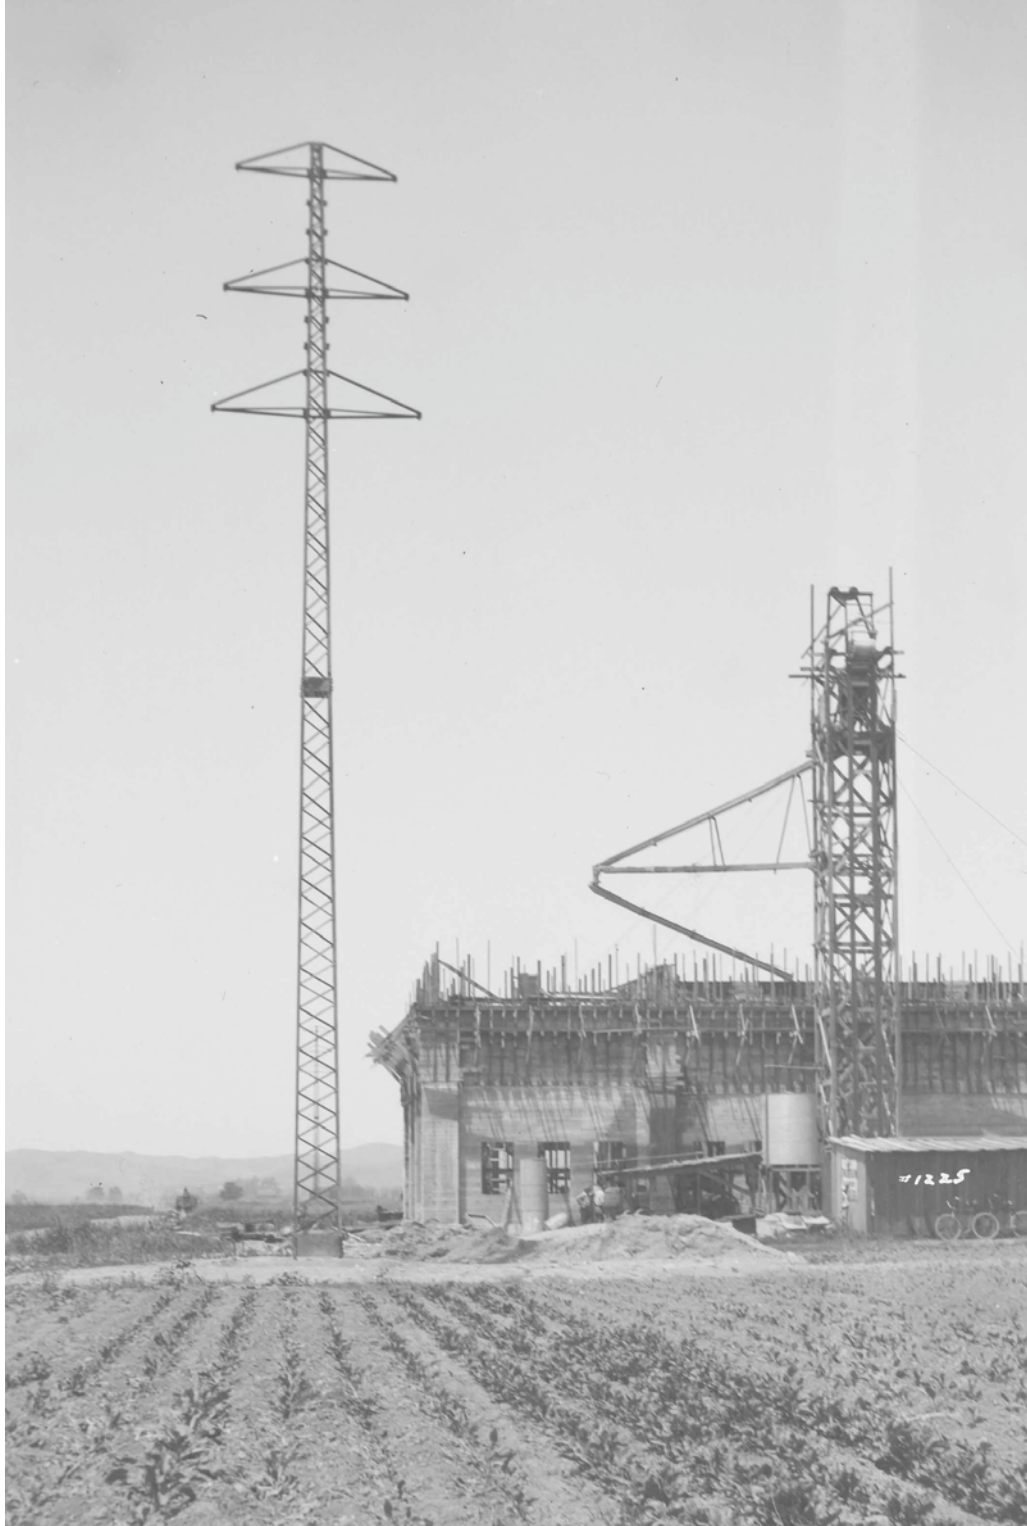
*Historic construction photo of the Chino Substation Building on former agricultural lands, circa 1911.
Image Source: Huntington Library Photo Archive – Southern California Edison Co. Collection (call #02-01225).*

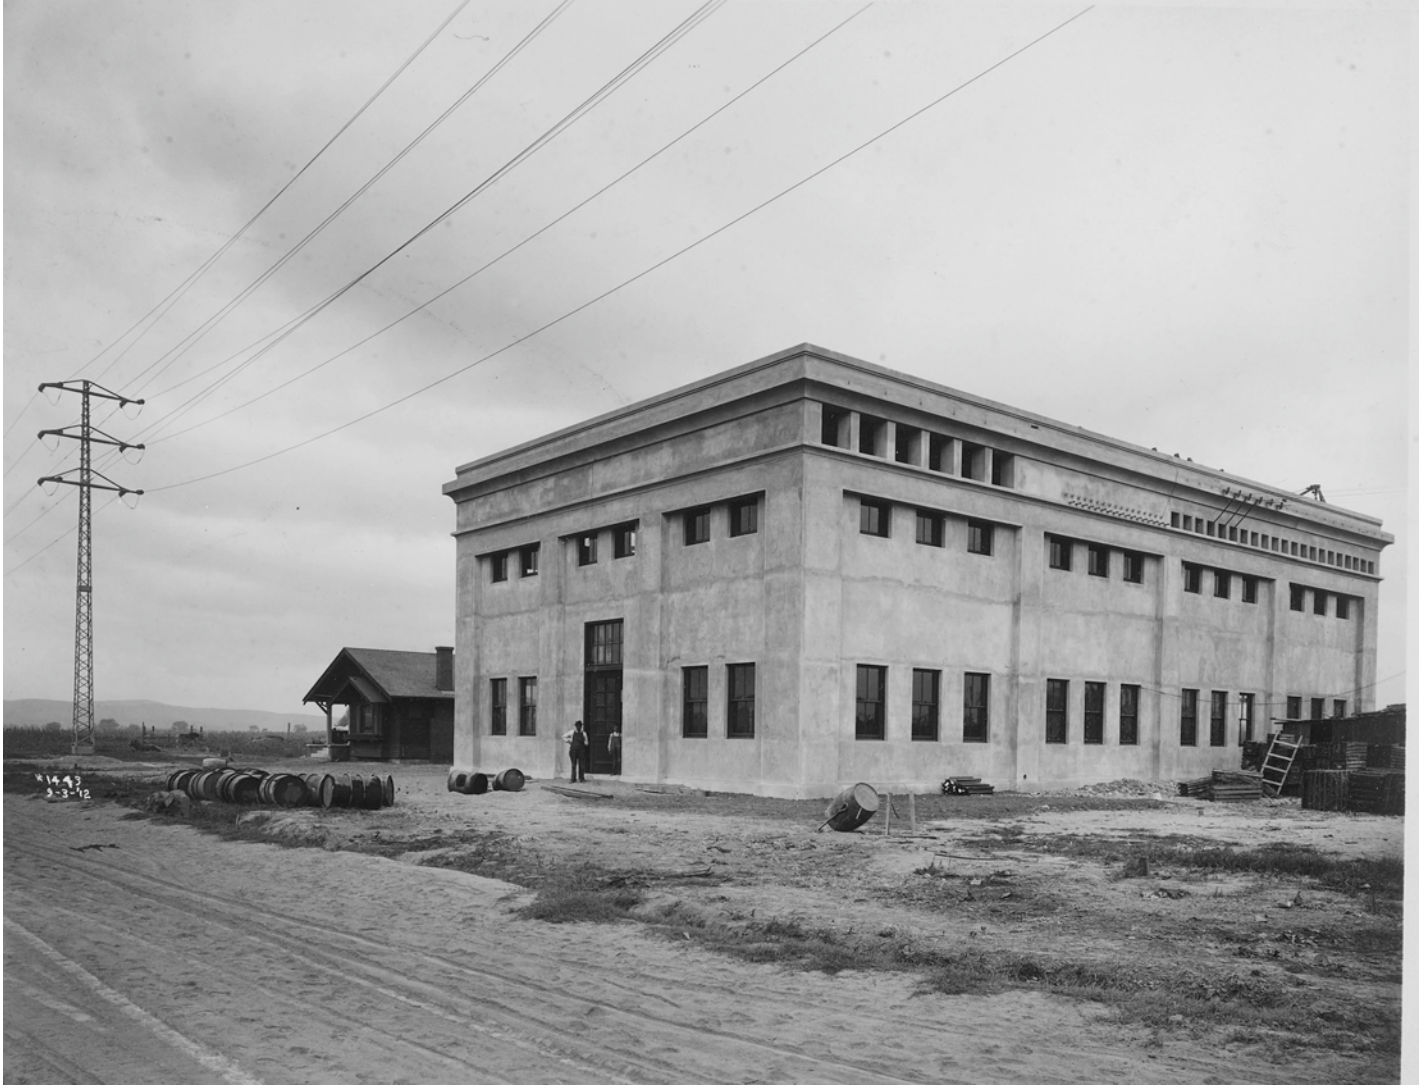
*Historic photo of the Chino Substation nearing completion, September 3, 1912.
Image Source: Huntington Library Photo Archive – Southern California Edison Co. Collection (call #02-01443).*

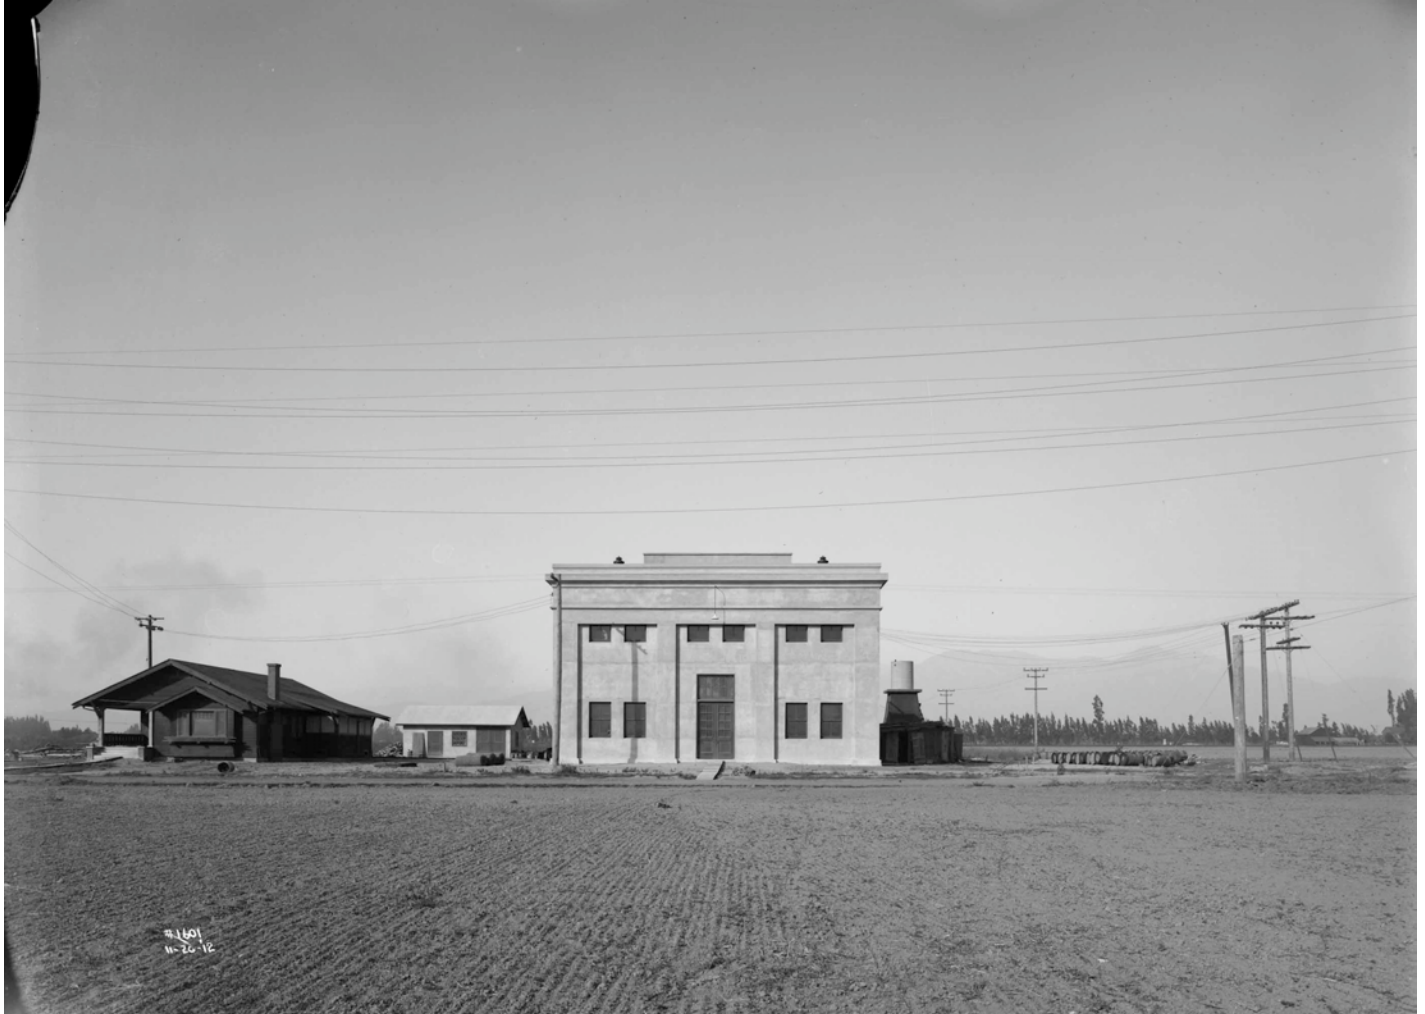
*Historic photo of the Chino Substation – view north of the south (front) elevation, November 20, 1912.
Image Source: Huntington Library Photo Archive – Southern California Edison Co. Collection (call #02-01601).*

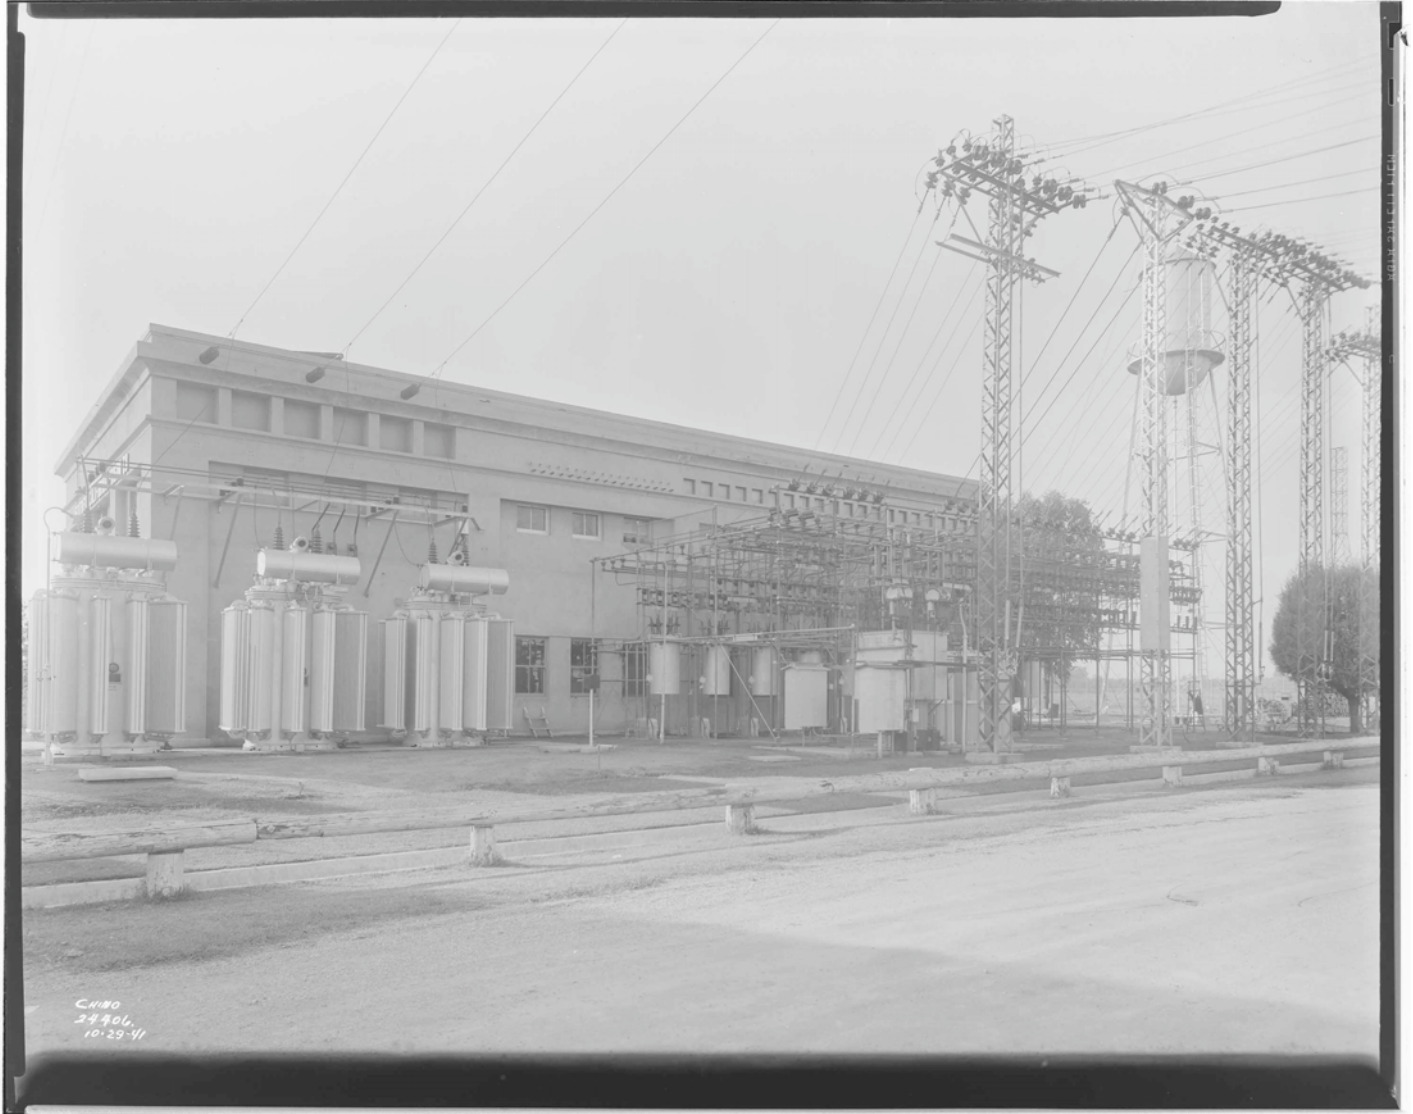
*Historic photo of the Chino Substation – view west of the east elevation, October 29, 1941.
Image Source: Huntington Library Photo Archive – Southern California Edison Co. Collection (call #02-24406).*

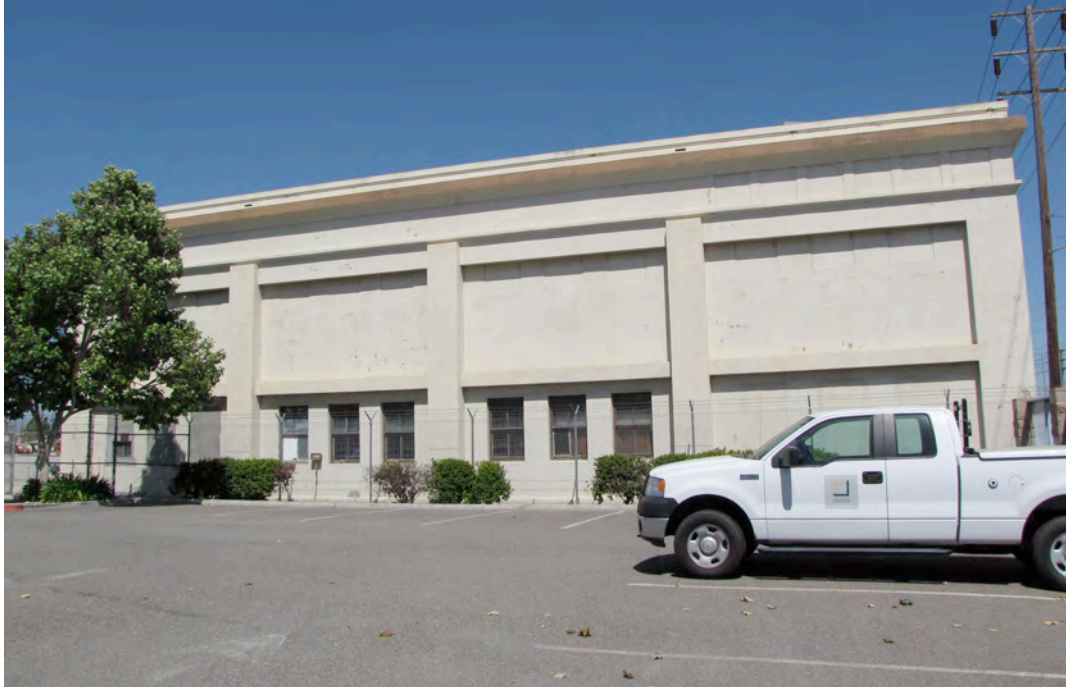
View east of the west elevation from the adjacent SCE parking lot where the Substation family homes were originally located. All second-story and frieze windows are painted over from the exterior. Some first-floor windows have been infilled, however, the fenestration dimensions are evident from cracking of the infill material.

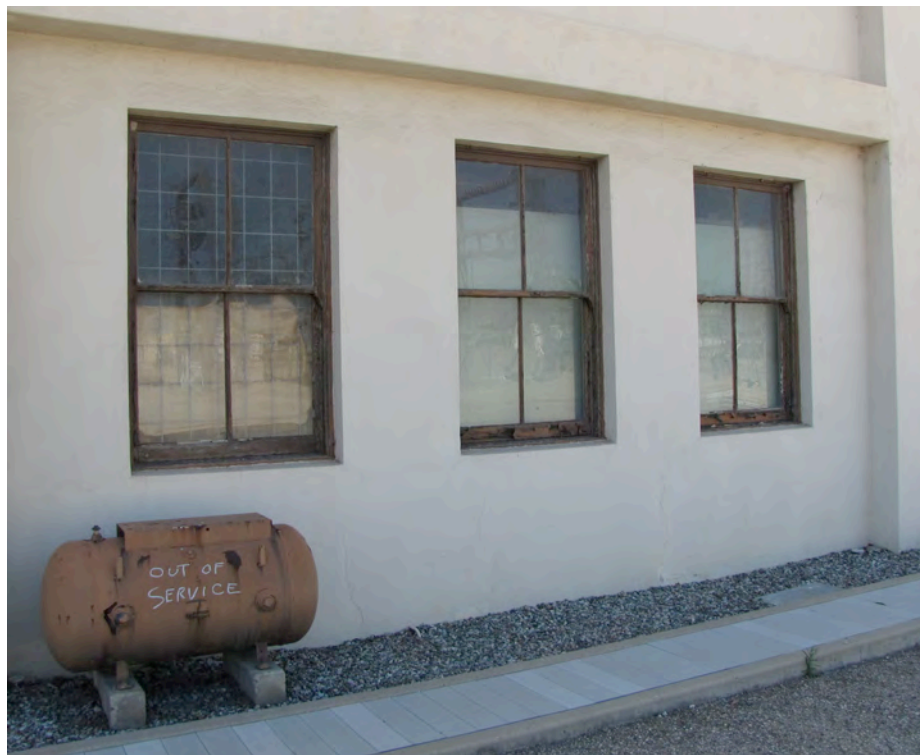
Typical historic two-over-two wood windows punched into the façade, with a cable raceway (trench) in the foreground.

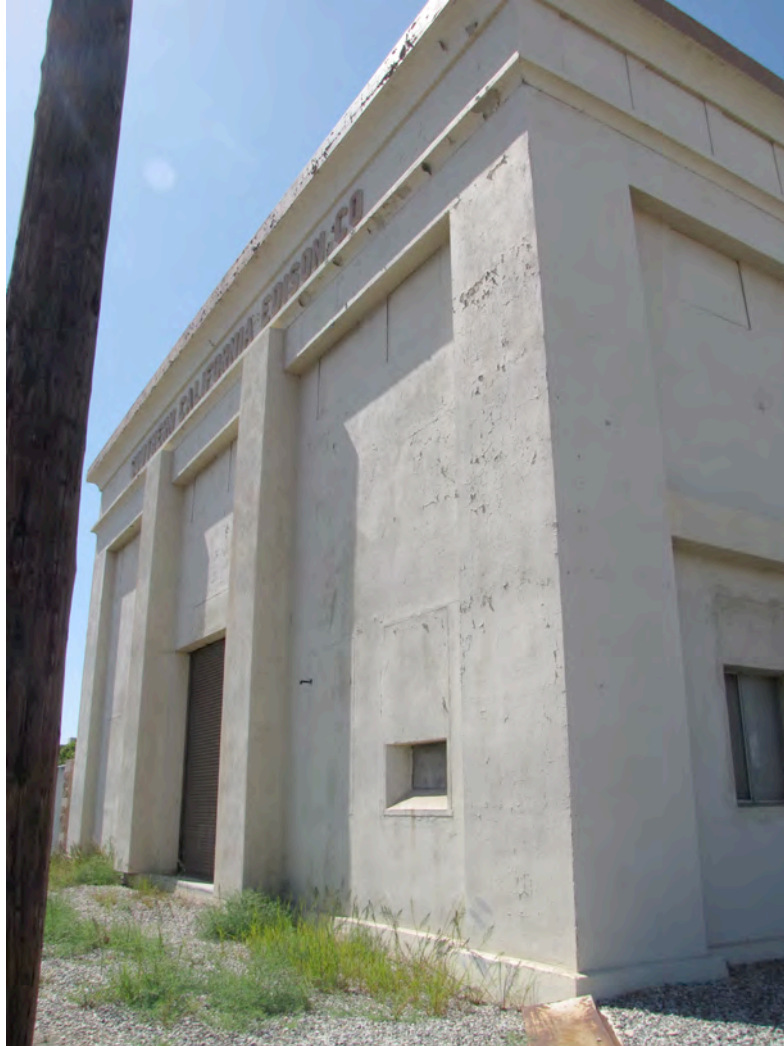
View westerly of the front (south) elevation, showing first floor fenestration alterations and painted-over second-story and frieze windows. The original dimensions for the first floor windows and door openings are still visible.

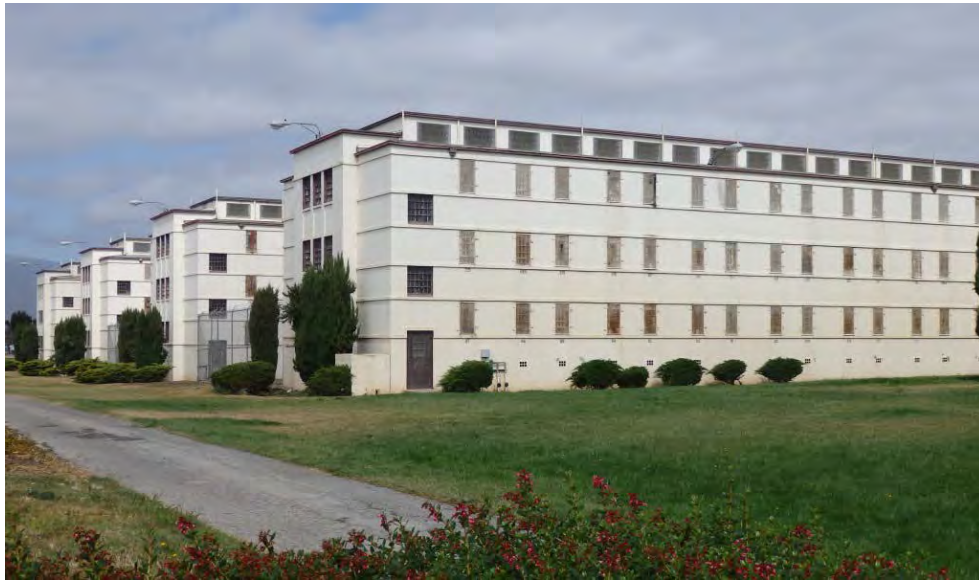
Exhibit 2. CTF-Central. Designed 1949, opened 1951.

In the 1950s, a new design, called the telephone-pole plan, or the mainline corridor, became popular in California. This plan consists of wings extending from a long central hallway; the two to three story wings have a variety of uses from cellblocks, hospitals, chapels, or administrative. The plan was developed for prison use by Sir Edmund DuCane at Wornwood Scrubs (1874 in London, England) and soon after by Henri Pousin at Fresnes Prison (1895 in Paris, France). The first prison in the United States to use the telephone-pole plan was the Minnesota State Prison at Stillwater (1913-14), designed by Clarence Johnston. This plan became the standard for high-security prisons worldwide after World War II as designers realized that large, lateral cellhouse plans provided too little flexibility for modern classification and separation of different types of inmates and made prisoners difficult to control (Johnston 2000:139-140). In its modern iteration, the wings are essentially identical from outside, plain concrete cube with barred windows and no exterior doors and access is through hallway only. In California, a number of prisons in the 1950s were constructed using the telephone-pole plan, including: CTF Central (1949) (Exhibit 2), CIM Facility B (1950) (Exhibit 3), DVI (1951), and CMF (1955).

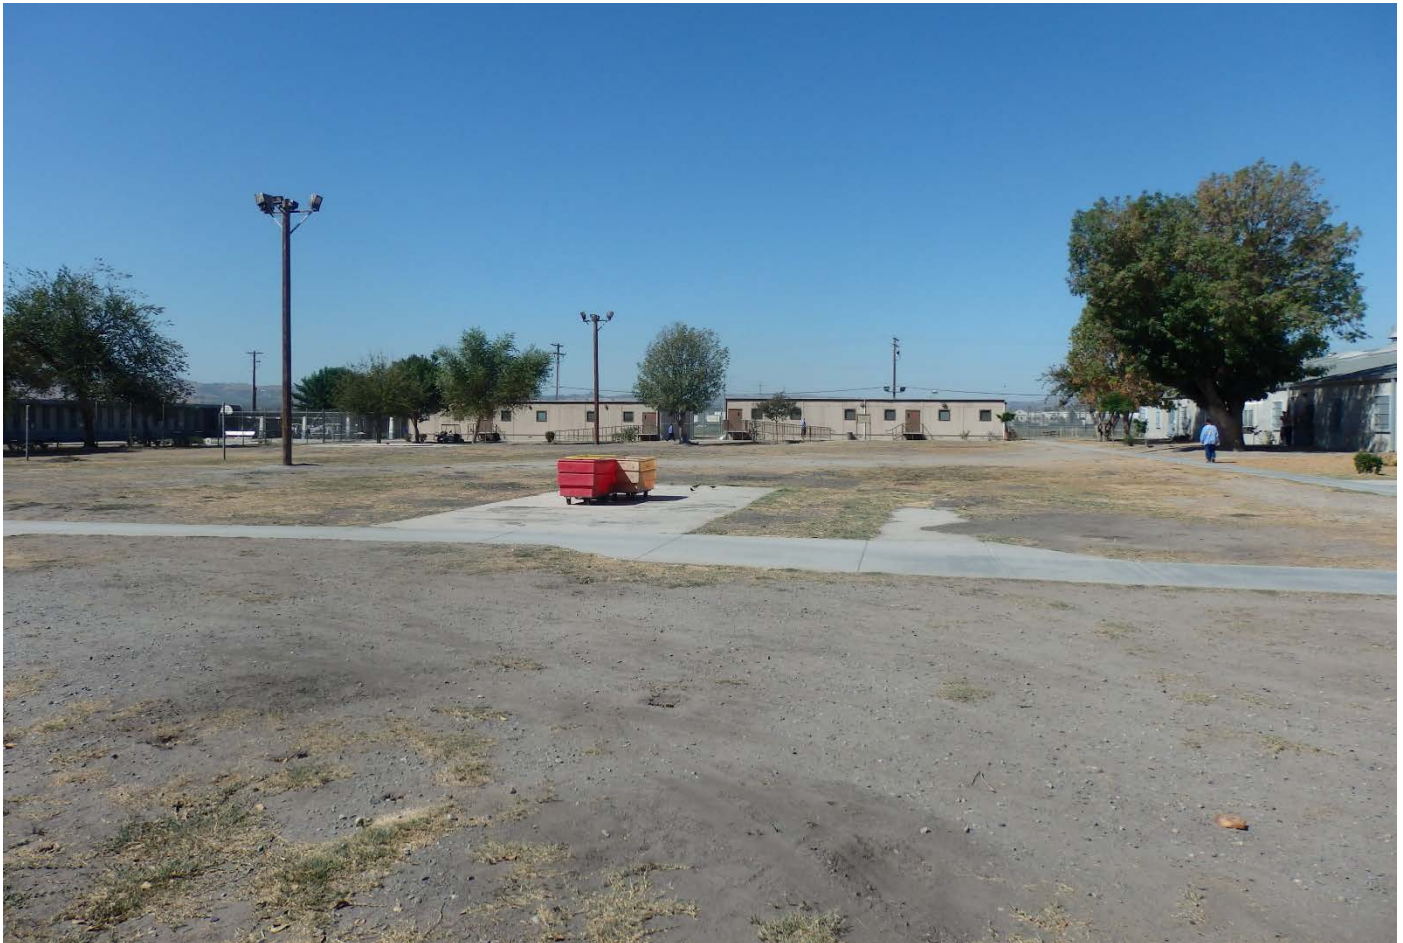
8/10

Facility D contains many styles of buildings, including brick, concrete masonry unit, corrugated metal, and a few that are somewhat Streamline Moderne in style. The buildings are a mix of one and two story, most with a gabled roof. The facility has a somewhat organic arrangement; buildings seem to have been constructed as needed wherever space was available. Inmate housing is located throughout the site, prison industry warehouses in the northeast corner, and education and vocational shops in the southeast corner. The landscaping at CIM-Facility D is not considered a contributing characteristic to the potential subdistrict as formal landscaping appears never to have been a part of the design of the overall facility. The old baseball field (now grassy open space at the center of the facility, though mostly dead at time of site visit), and some mature trees are the only landscaping.

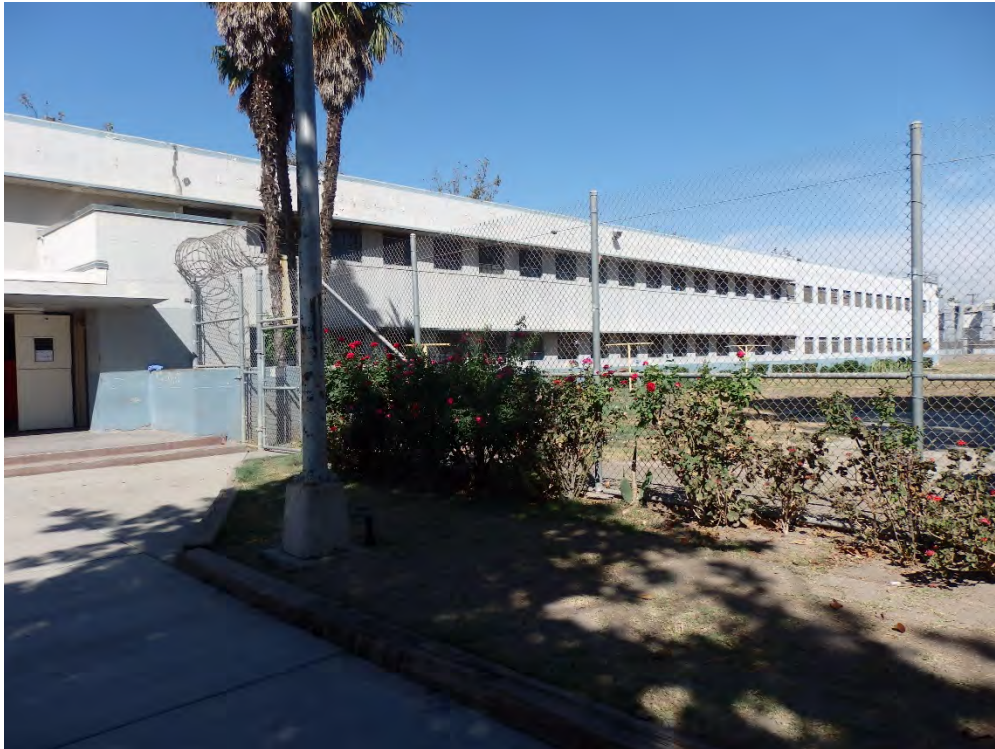
North end of building. Projecting cornice and balcony do not extend over northern-most 85 feet.

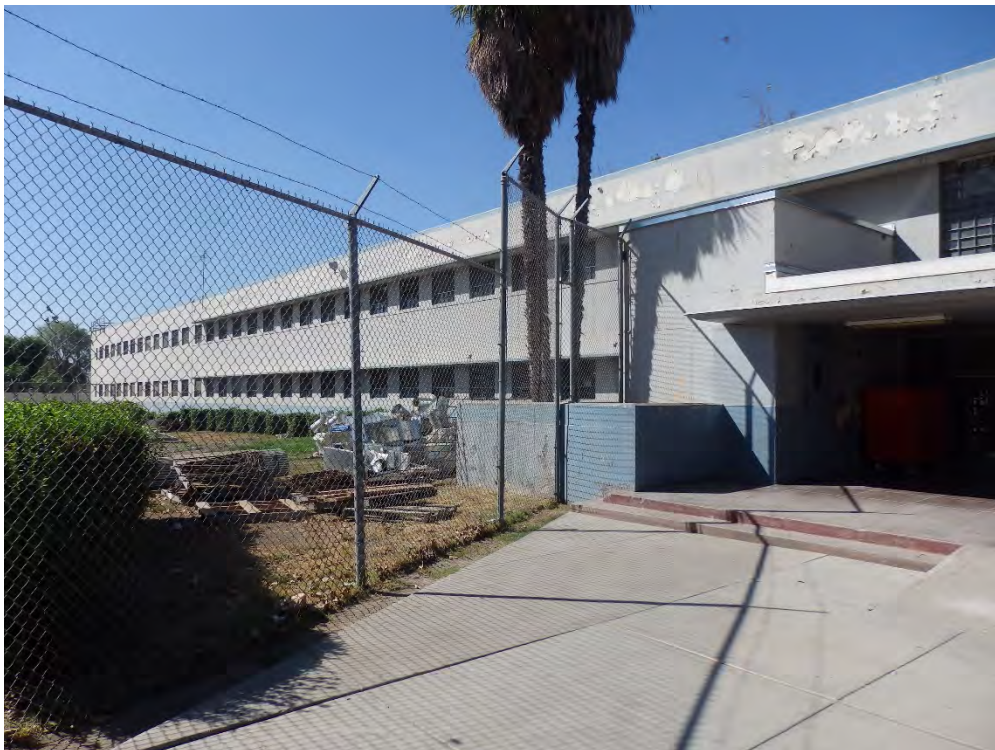
South end of building. Projecting cornice and balcony do not extend over northern-most 85 feet.

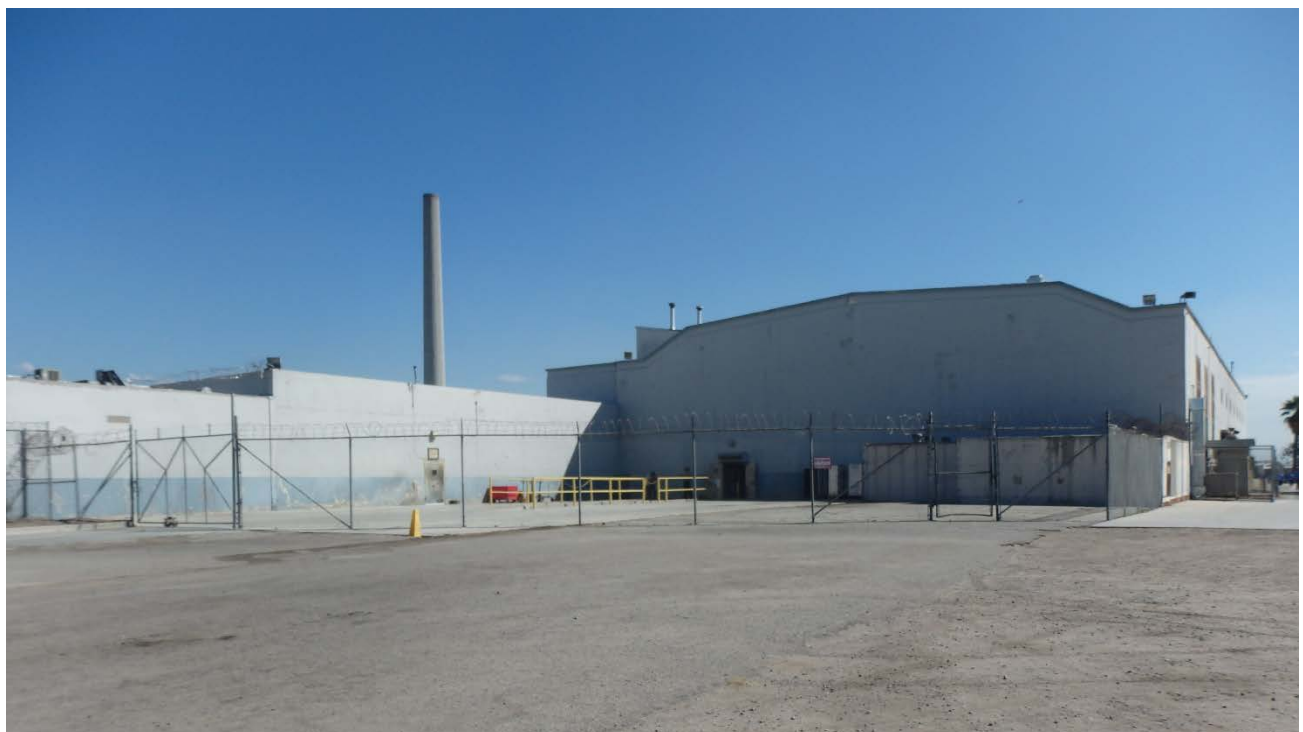
Rear of culinary building. Bakery addition to shorter northern building at far left.

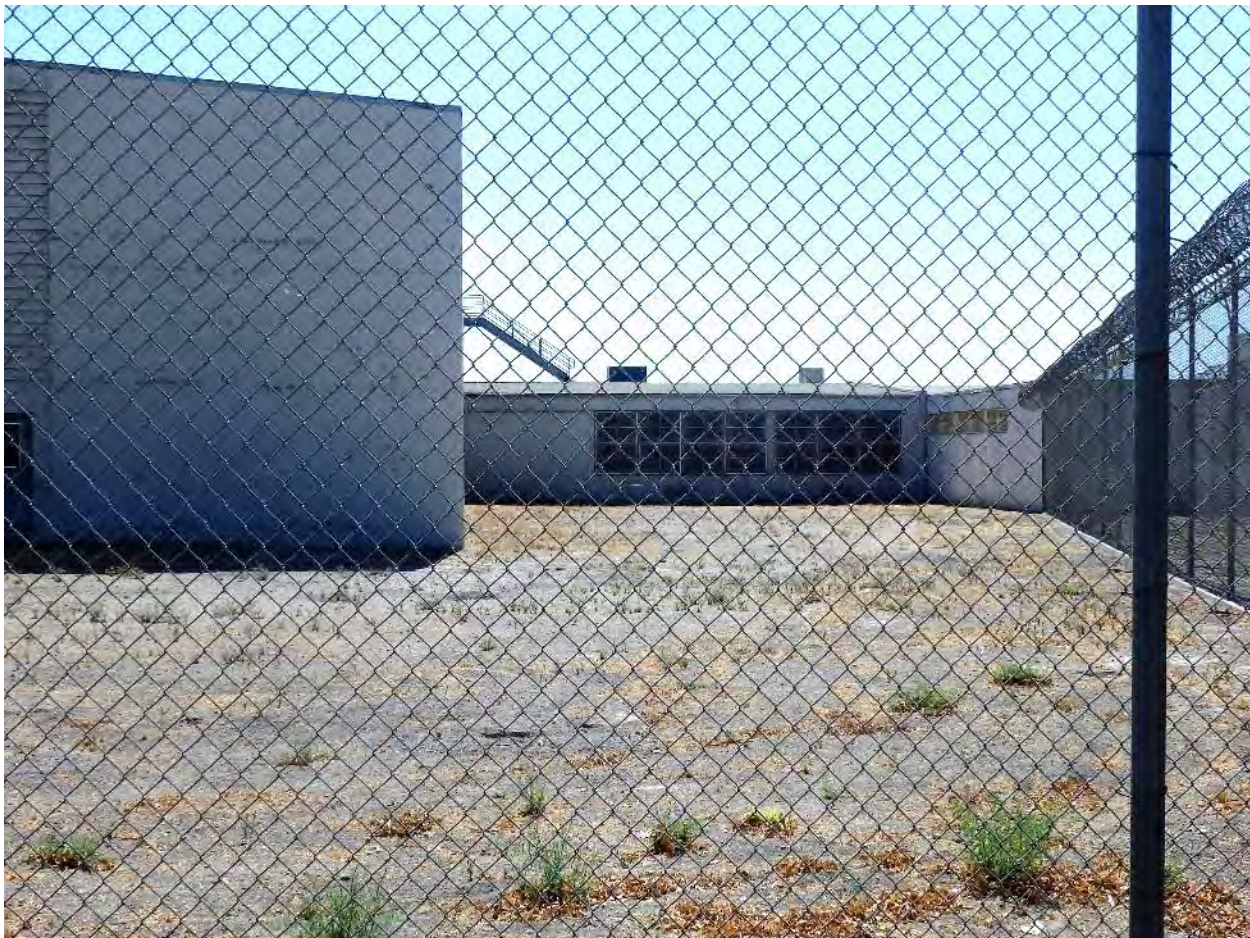
Central hallway connecting administration building to the two-story Cypress Housing Unit (left).

The central hallway is approximately 900 feet on an east-west axis (pictured below). The wings that extend from the hallway include the five housing units, vocational and educational wings, and other institutional needs such as laundry, dining, the gym, and the administration building. The landscaping at CIM-Facility B is not considered a contributing characteristic to the potential subdistrict because CIM-Facility B was designed for internal movement and does not contain much "outside" space. A patch of grass and some pine trees are located at the entrance of the administration building.

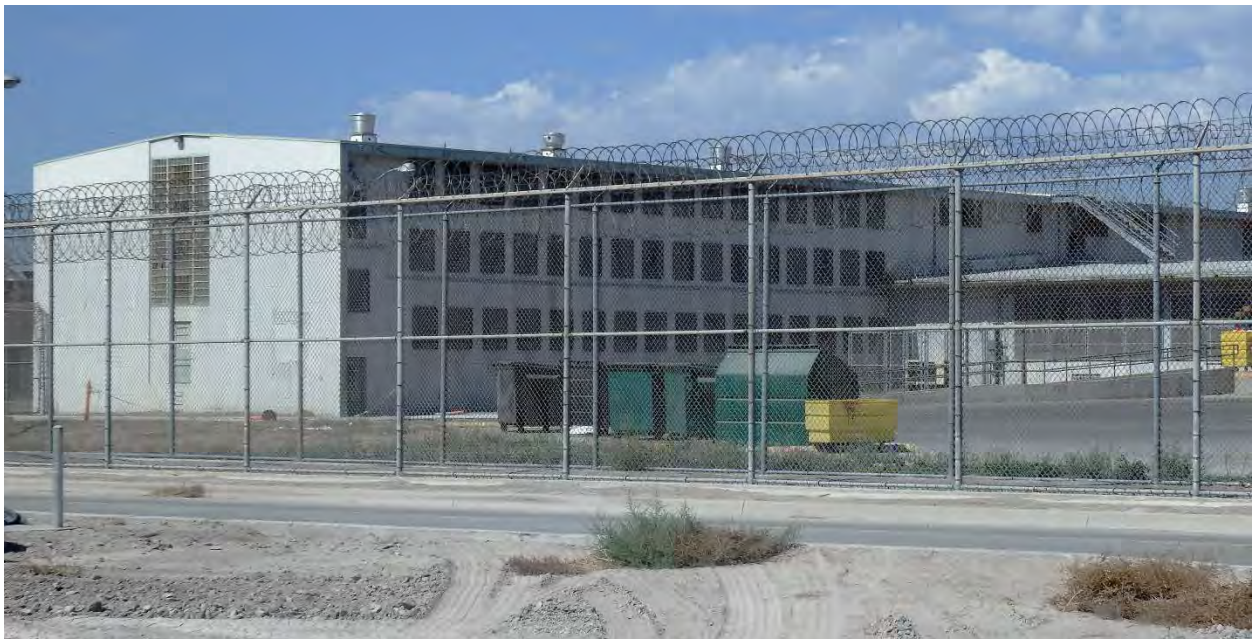
Three-story Madrone Housing Unit extends approximately 95 feet from single-story central hallway (right).

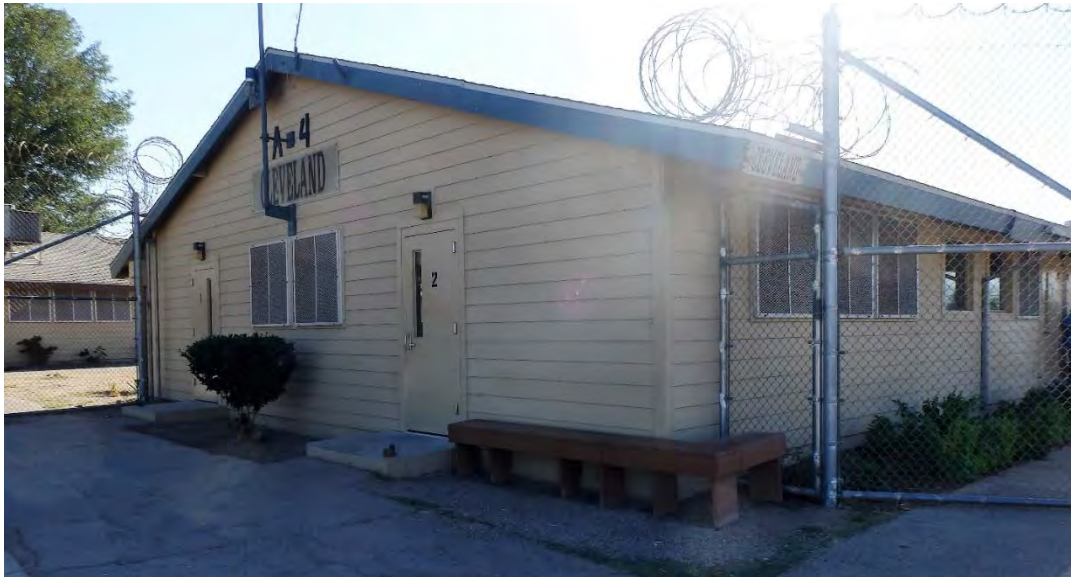
Dormitory buildings arranged with small courtyard between.

The facility is arranged based on eight single-story dormitories which are set at an angle on the east and west sides of a central open area. The administration, medical clinic, and visiting buildings are located to the north of the open area, while the culinary, chapel, and education buildings are to the south. While the dormitories are in good repair, the other buildings show signs of neglect. The landscaping at CIM-Facility A is not considered a contributing characteristic to the potential district because aside from the grassy open space at the center of the oval (mostly dead at time of site visit) and a few vegetable gardens maintained by inmates, formal landscaping appears never to have been a part of the design of the overall facility.

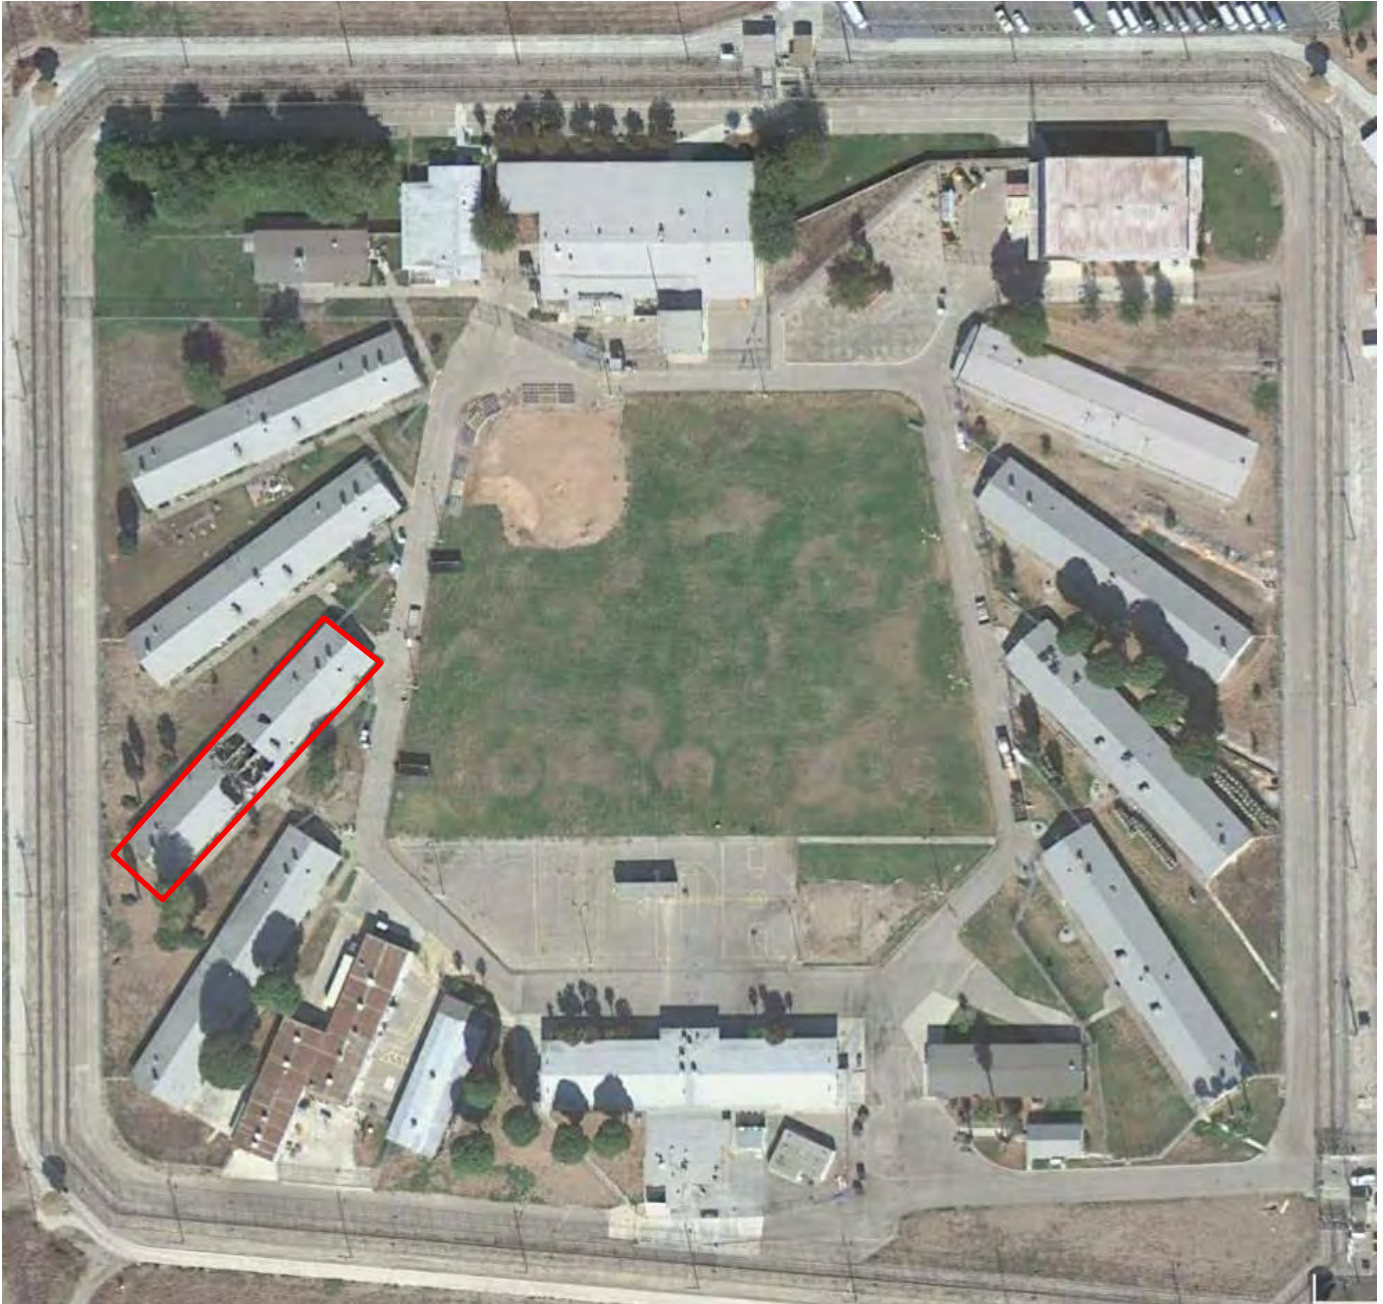
Facility A, November 2009. Damaged Joshua Dormitory in red.

On August 8, 2009 a riot occurred at Facility A and Joshua, Mariposa, Otay, and Angeles housing units were damaged. In addition to internal building repairs, all of the housing units were completely renovated as single-story insulated wood clad buildings constructed on the existing concrete foundation/slab floors. Joshua Dormitory also required additional repairs to the roof.
